NACA RM E52K13

# RESEARCH MEMORANDUM

PRELIMINARY INVESTIGATION IN J33 TURBOJET ENGINE OF SEVERAL  
ROOT DESIGNS FOR CERAMAL TURBINE BLADES

Lewis Flight Propulsion Laboratory  
Cleveland, Ohio

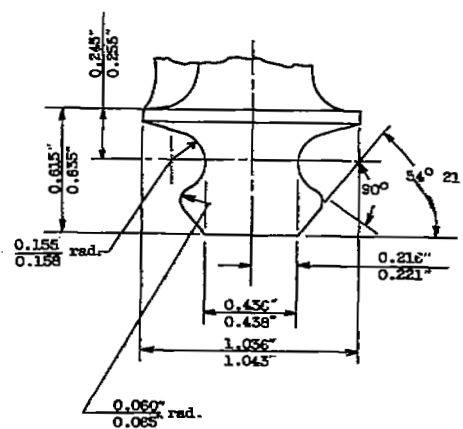
(d) Dovetail root.

Dovetail run. - In this run mechanical failure of engine accessories necessitated three emergency shutdowns. These did not result in visible damage to the blades. After 58 hours and 28 minutes of operation at rated speed, one blade failed across the root (fig. 9) and damaged both the adjacent ceramal blades and the ceramal blades on the opposite side of the wheel, as well as several alloy blades (fig. 10). An enlarged view of this failed root is shown in figure 11. From the impression of the screen on the blade, it is evident that the screen was plastically deformed during the test. A sharp line of contact between the screen and the root can be noted in the figure. The cracks appear to follow this line. The stress concentration which caused the failure may have existed in this area.

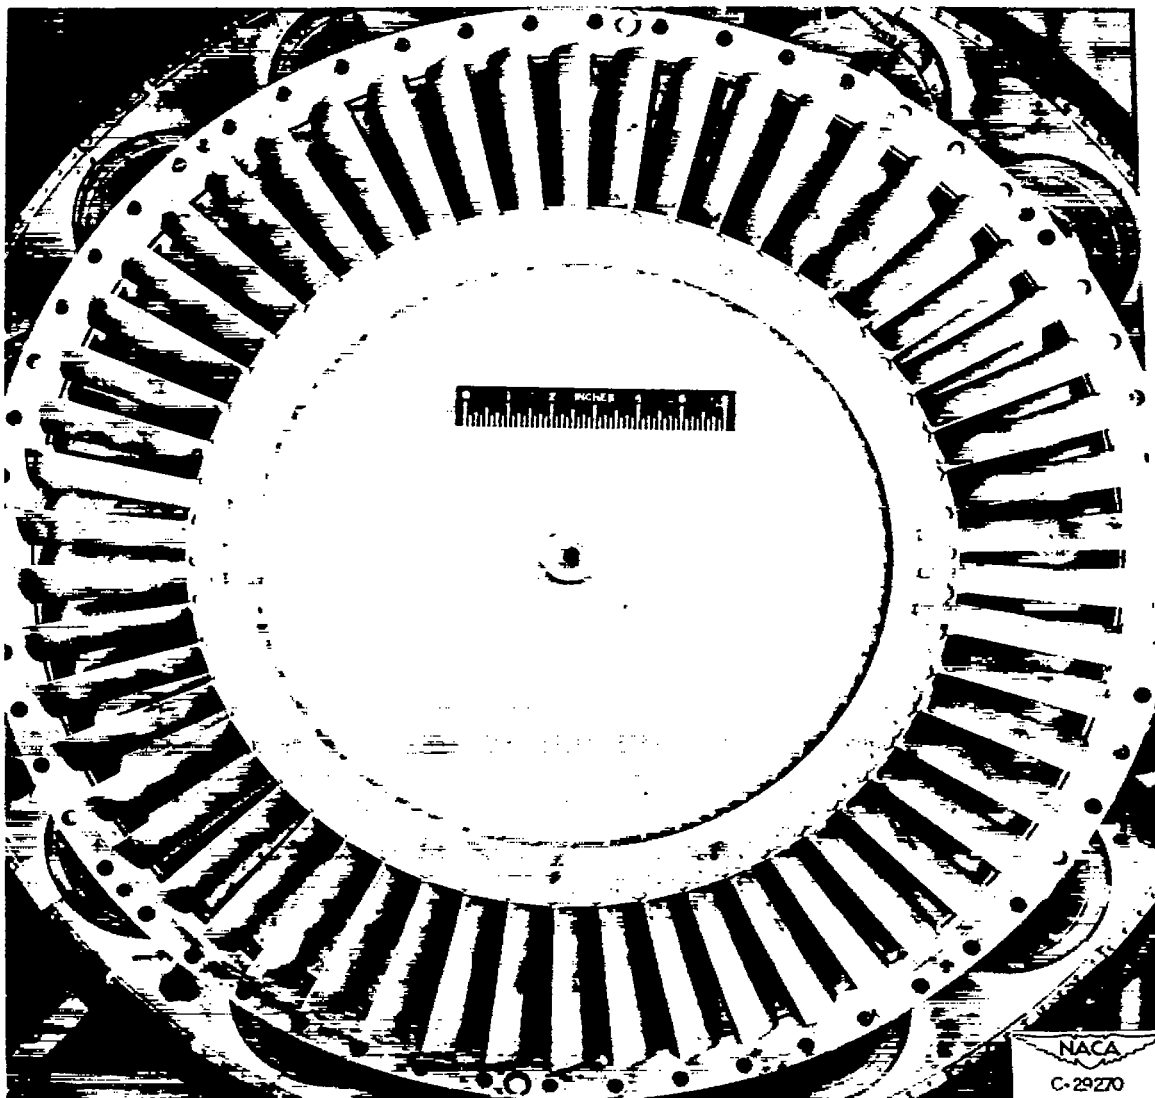
Figure 9. - Ceramal turbine blades having 4-pin type roots prior to operation.

4-pin blade runs. - As in the previous run this wheel was bladed with two diametrically opposed clusters of three ceramal turbine blades (fig. 9). After 1 hour and 40 minutes of operation the fuel pump to the
